TEST REPORT

No. : SZML130602870

Sample Name : WS25
SGS Ref. No. : SHMR130706558
Test Required : IP6K8
Ref. standard : DIN 40050.9-1993
Date of Receipt : Jul. 01,2013
Test Period : Jul. 01,2013 to Jul. 02,2013

Sample Description: plastic enclosure

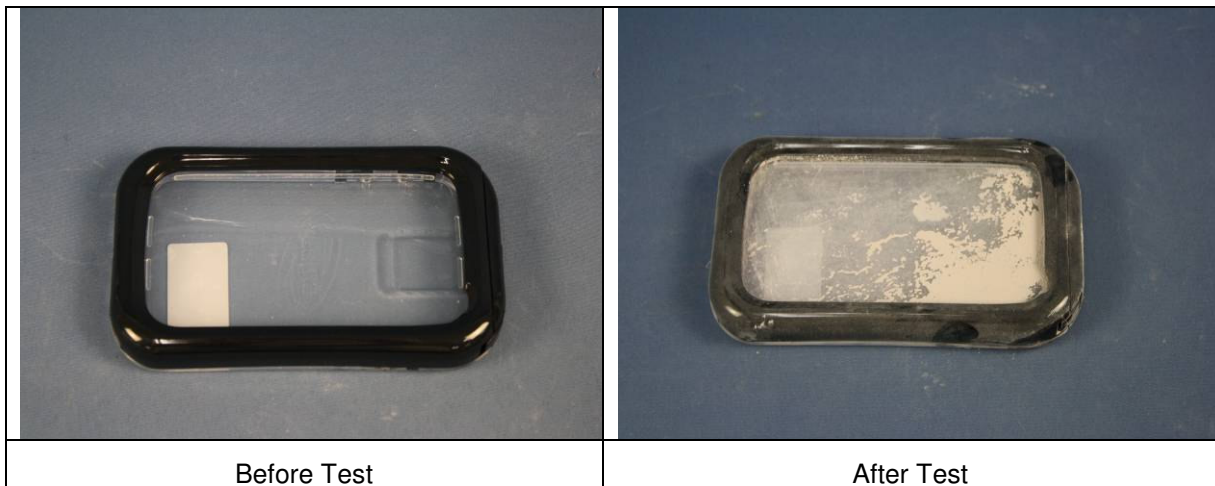
Test Photos:

Test Item 1: Dust Test (IP6KX)

Test Dust: a mixture of 50% by weight limestone and 50% fly ash with the following particle size distribution: 33 parts by weight ≤32µm; 67parts by weight >32µm but ≤ 250µm (2kg/m3 chamber volume and be kept in suspension during the test)

Operating Methods: 6s movement of the dust mixture/ pause of 15minutes. / 32cycles

Test Duration: 8 hours

Sample No.	Check After Test
#1	Dust ingress was not found in the sample after test

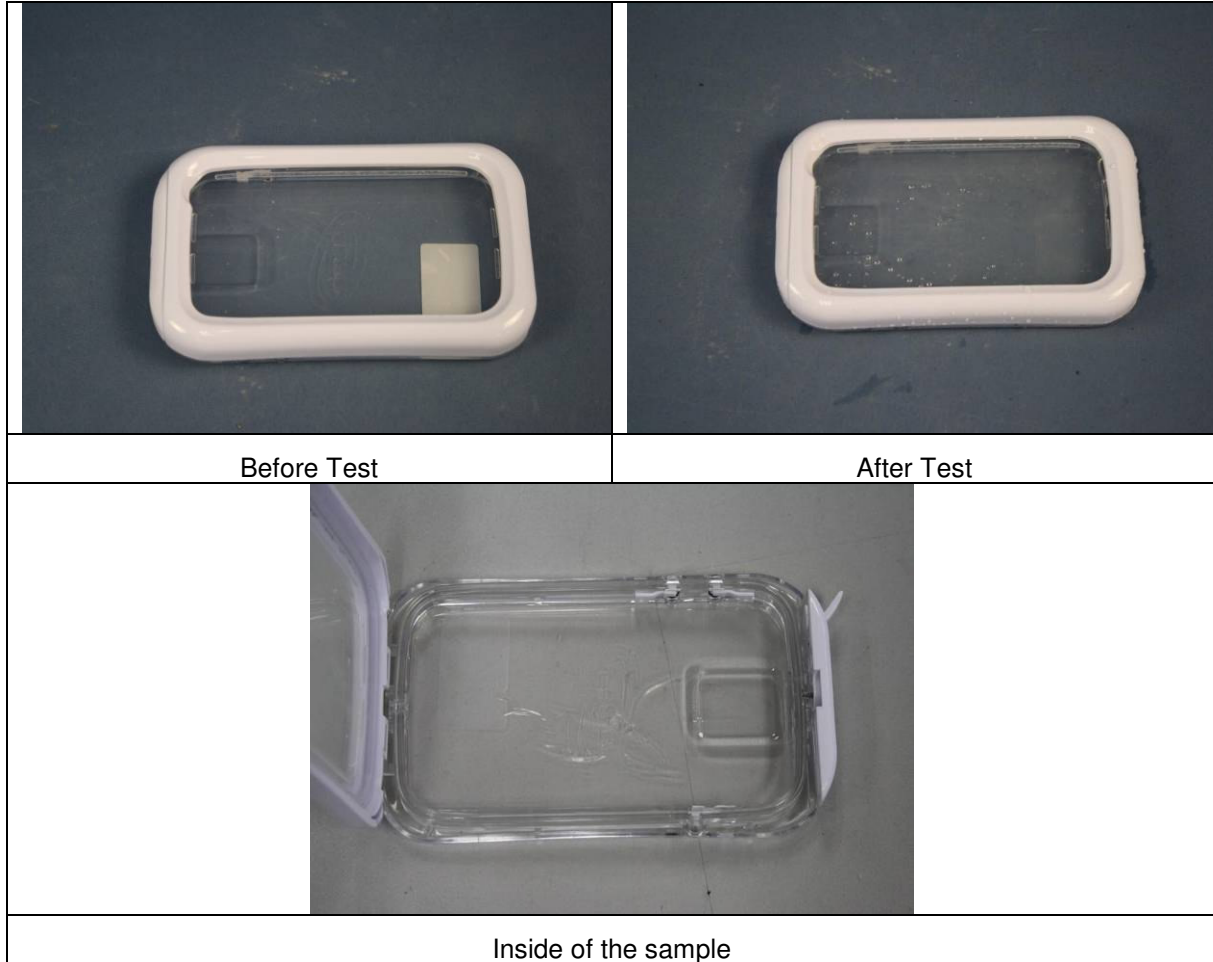
Test Photos:

Test Item 2: IPX8

Depth: 6m

Test Duration: 8h

Sample No.	Check After Test
#2	Water ingress was not found in the sample after test
